National Register of Historic Places  
Registration Form

Historic name Teske Farmstead

Historic Agriculture-Related Resources of Kansas MPS  
Section Number 7 Page 1

Teske Farmstead  
Pottawatomie County, Kansas

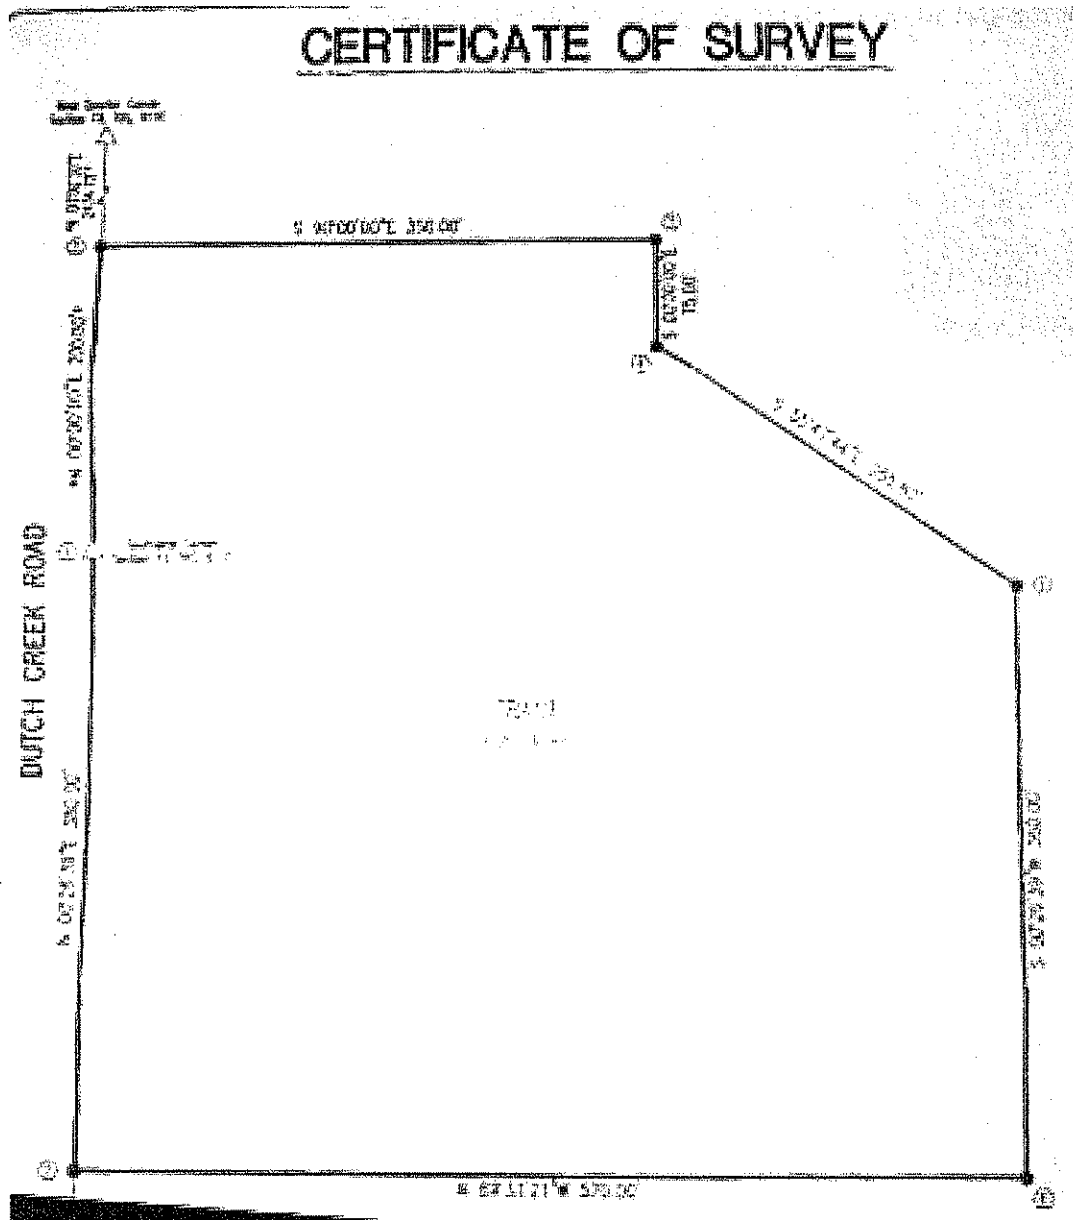
Diagram of land survey provided by current owners, Victor and Claudia Janousek  
(conducted 2002 by Sloan Meier Engineers, Manhattan)

Beg SW COR of SW QTR (Corner 1), thence E 200' (Corner 2), thence S90' E350' (Corner 3), E 75' (Corner 4), S55.47'.44" E265'.8" (Corner 5), S26'39" W360' (Corner 6), N89'33.21" W570' to west line of NW QTR, thence N26'39" E380' along west line of NW QTR to POB (survey diagram follows).

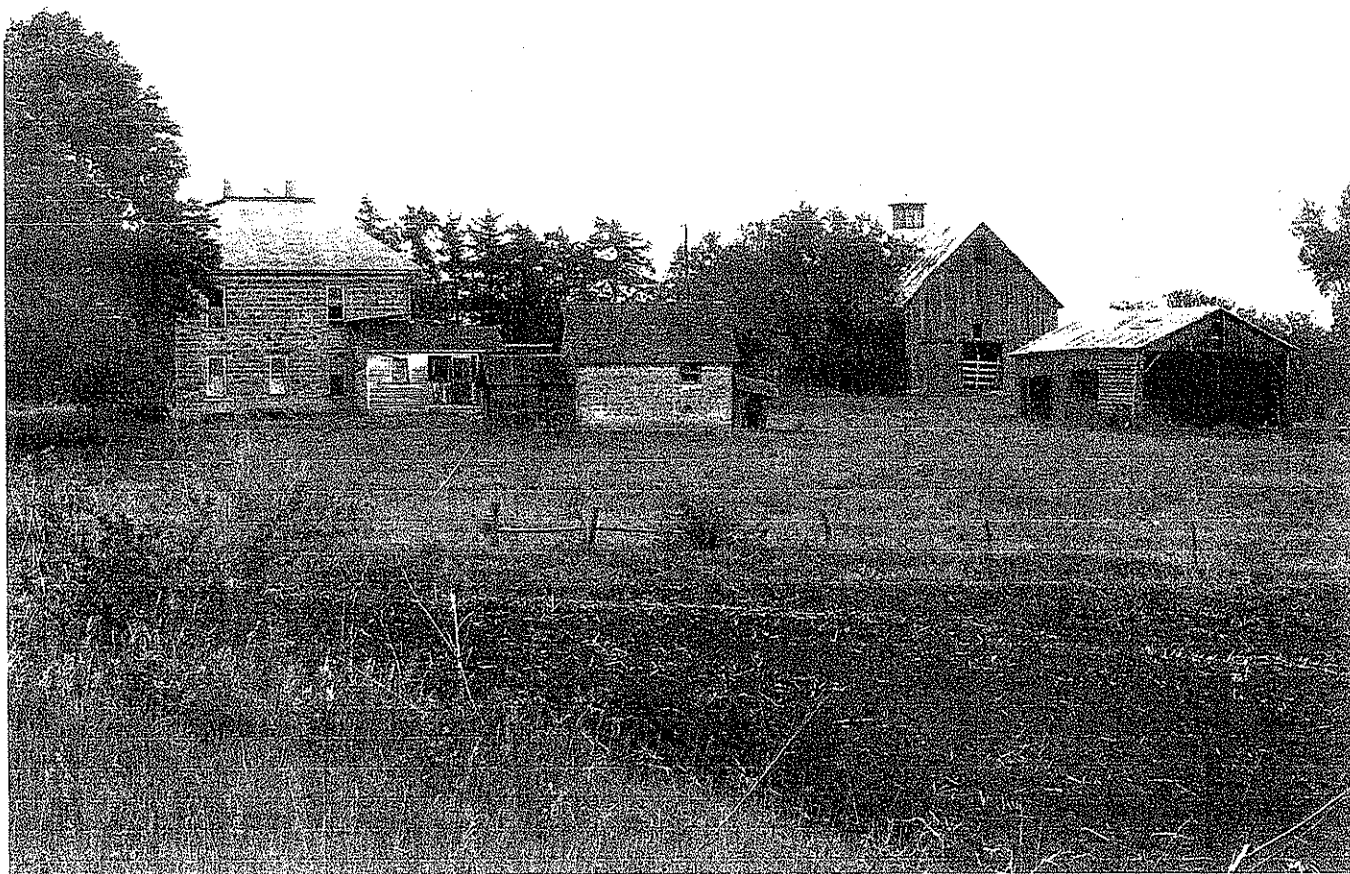
Upper-Ferdinand Teske's Justice of the Peace seal (from photocopy of a will, provided by current owners)  
Lower-1970s view of Teske Farm, provided by current owners and available at the Onaga Historical Museum.

The account of the tornado noted that "the large new barn and cattle shed, and the granary" were lifted off their foundation and destroyed.<sup>2</sup> The existing barn was constructed after the tornado. A c.1970s photo illustrates the existing chicken house northwest of the barn and a frame shed south of the barn. The south shed, which has since been removed, may have been rebuilt on the foundation of the original granary. Remnants of the stone foundation mark the location of the granary/shed. The chicken houses are extant in the photo but no record has been found to document the dates of construction.<sup>3</sup>

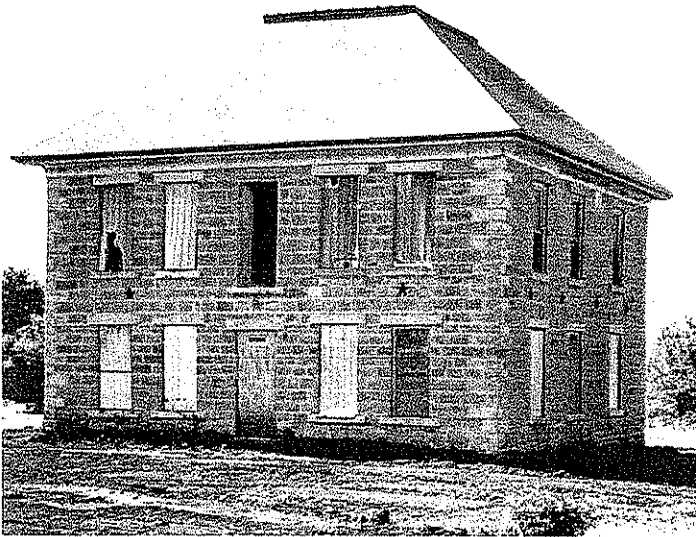
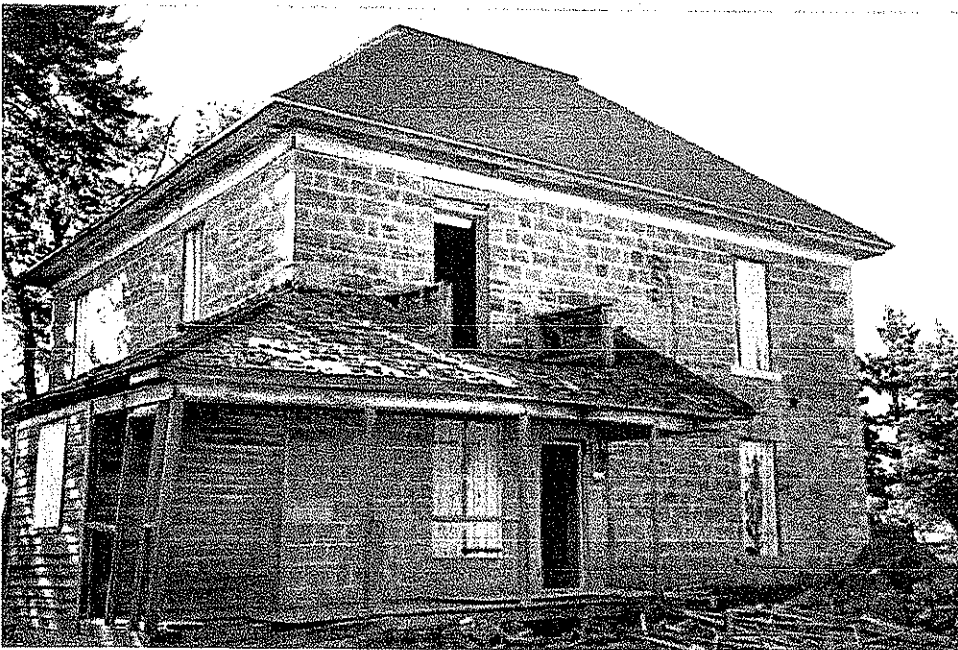
*View of Farmhouse when current owners purchased farmstead in 2002, before renovation.  
Upper- North and West Facades  
Lower- South and East Facades*

The existing farmhouse pre-dates the barn by more than thirty years. The two-story house is constructed of native limestone. The plan form is square and the house has a hip roof and a entry porch in the center of the north, front facade. The central entry is flanked by regularly-spaced double-hung windows creating a formal symmetry typical of the Georgian Revival style. Dressed stone quoins at the corners frame each facade. Bolts extant on the front of the house and reflections of Teske descendants indicate that the original porch was wider (but not full-width) and had a sleeping porch on the second floor.

The house retains its original form and roof shape although twin chimneys have been removed. The existing metal roof is a contemporary replacement; the original roof was likely wood shingles. A one-story shed porch wraps around the southeast corner of the house. A bathroom, which was formerly enclosed on the west end of the south porch, was removed in the recent remodeling. The porch is now screened but maintains its historic configuration. The house had been vacant for approximately fifty years and was in deteriorated condition when it was purchased by the current owners in 2002. It has undergone extensive repair and remodeling to return it to a livable home. The doors and windows were deteriorated and many missing. The openings had long been boarded up. The remodeling maintained the original openings with few exceptions and reused original interior trim where possible. The existing windows are replacement 1/1 double-hung windows. The only openings that have been modified are a second-floor window on the east facade that had been converted to a door to provide access to the roof of the east porch. This opening was returned to a window. A doorway that formerly led to the south porch was infilled to accommodate cabinets in the kitchen. The interior configuration is a standard four-square plan with kitchen, dining room, living room and parlor on the ground floor and four bedrooms upstairs. The stairway is centrally located and accessed in the center of the south side of the home, aligned with the front entrance in the center of the north facade. Formerly enclosed, the stairway has been opened at the foot of the stairs, between the kitchen and dining room, and opened on the second floor creating a sitting room in the southwest corner in place of the fourth bedroom. Interior bathrooms were added to the first and second floors in the center of the east half of the house. Although the interior was in very poor condition after standing vacant for years, some original features were salvageable such as the original flooring on the second floor, some interior trim, and special features such as the double-doors between the living and dining room. The structure of the ground floor was collapsed and had to be reconstructed. A small cellar was originally located in the center of the south side of the house and a new crawl space was added beneath the entire house to accommodate mechanical systems.
